Moravian Health Centre

Client: Moravian of the Thames First Nation
Size: 3,665 ft² (340.5 m²)
Cost: \$325,000 construction cost
Architect: Two Row Architect
Officially Opened: Sept. 1996
Builder: Bronnenco Construction Ltd.

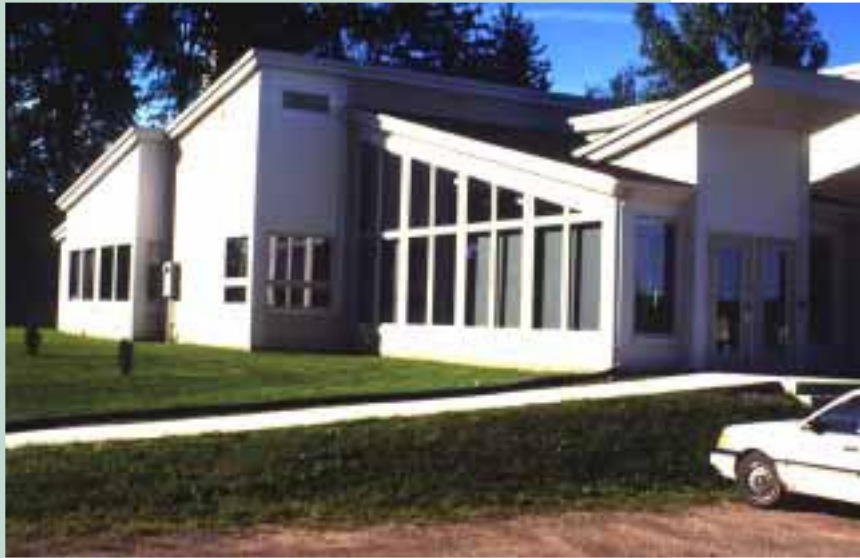
Exterior Elevation

The building's roof line remains low, however entrances are marked with shed roofs to direct rain water away. Their position, and that of other openings, have been located for protection from prevailing winds and weather.
